DEPARTMENT OF TRANSPORTATION

Quality Assurance and Source Inspection

WELDING INSPECTION REPORT

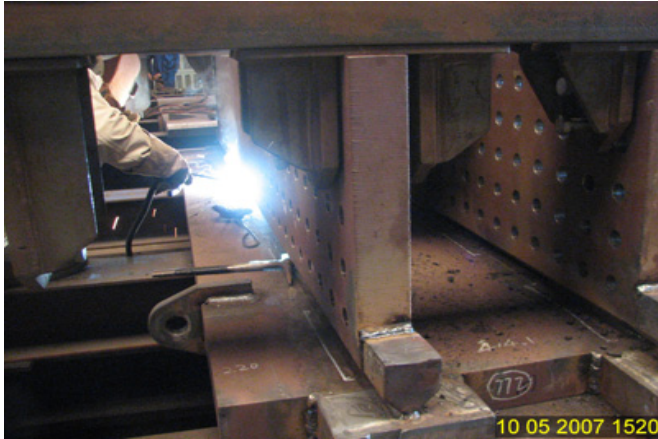
Caltrans QA Inspector observed ZPMC shop personnel performing Shielded Metal Arc Welding (SMAW) at Mock-up # 114.00 assembly A65 stiffener tack welds at weld joint # 1. Welding was performed by certified welders Guo Dengyun (037997) and Zhang Xiangrong (066763) in accordance to WPS-B-P-2212-TC-U5b. Both welders appeared to be performing proper inter-pass cleaning techniques. The following digital picture below illustrates welding in progress.
